检测报告

报告编号 A2200001369102003E
Report No. A2200001369102003E

样品名称 助焊剂
Sample Name FLUX
样品型号 N99
Part No. N99
客户参考信息 QL/HB/RD/YW-N99/N99A/N992A/N993A/N996A/N99B/N992B/N993B/N993C/N99C/N992C/N99D/N992D/N993D
Client Reference Information QL/HB/RD/YW-N99/N99A/N992A/N993A/N996A/N99B/N992B/N993B/N993C/N99C/N992C/N99D/N992D/N993D
样品接收日期 2020.01.02
Sample Received Date Jan. 2, 2020
样品检测日期 2020.01.02-2020.01.07
Testing Period Jan. 2, 2020 to Jan. 7, 2020

检测要求 根据客户要求, 对所提交样品中的氟(F), 氯(Cl), 溴(Br), 碘(I)进行测试。
Test Requested As specified by client, to test Fluorine (F), Chlorine (Cl), Bromine (Br), Iodine (I) in the submitted sample(s).

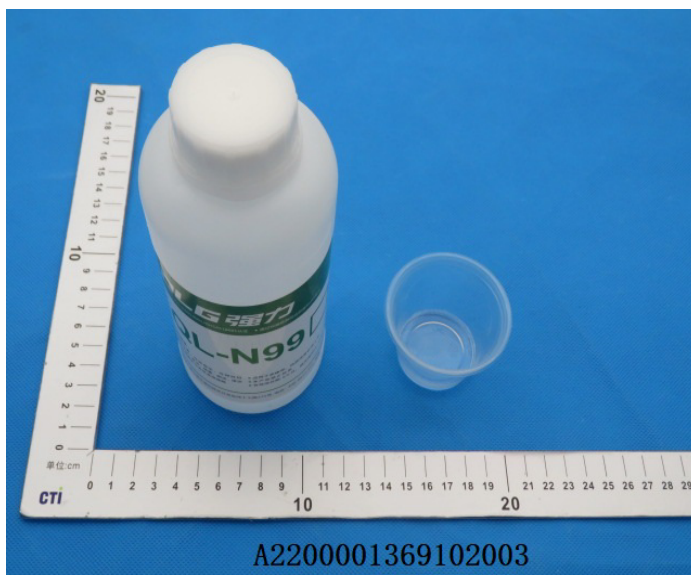
样品图片 Photo(s) of the sample(s)

样品/部位描述 无色透明液体
Sample/Part Description Colorless transparent liquid
